## LIMA\_11\_SV\_14\_5KCRUSH

Company:  
 User:  
 Result file: C:\CamsizerXT\CAMDAT\LIMA\_11\_SV\_14\_5KCRUSH\LIMA\_11\_SV\_14\_5KCRUSH077.rdf  
 Task file: C:\CamsizerXT\CAMSYS\LIMA\_11\_SV\_14\_5KCRUSH.afg  
 Time: 5/20/2015, 13:29, duration 26 min 24 s at 0.5 % covered area, image rate 1:1, with X-Fall, gap width = 7.0 mm

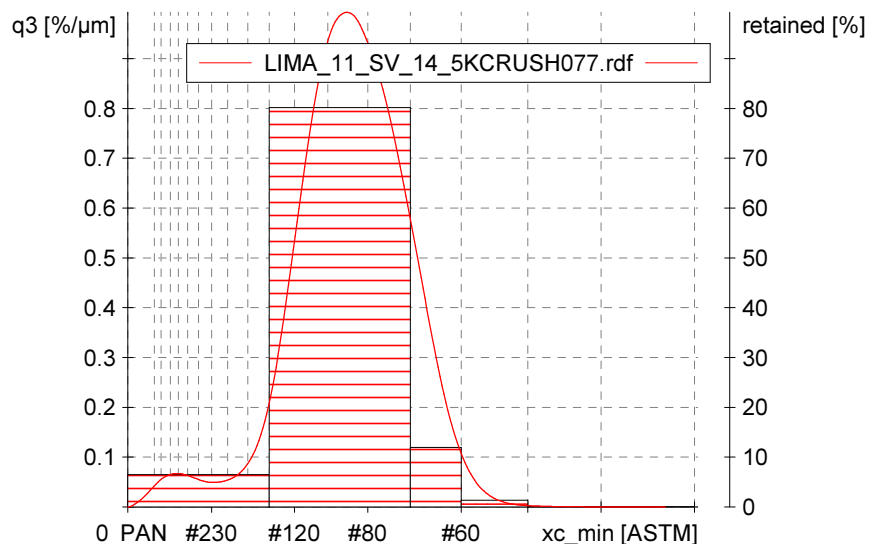
Particle model: xc\_min  
 No. of particles: CCD-B = 32409455, CCD-Z = 0  
 Velocity adaption: no  
 Fitting: no

## Characteristics

| Q3 [%] | x [μm] |
| 10.0 | 118.2 |
| 50.0 | 168.0 |
| 90.0 | 218.2 |
